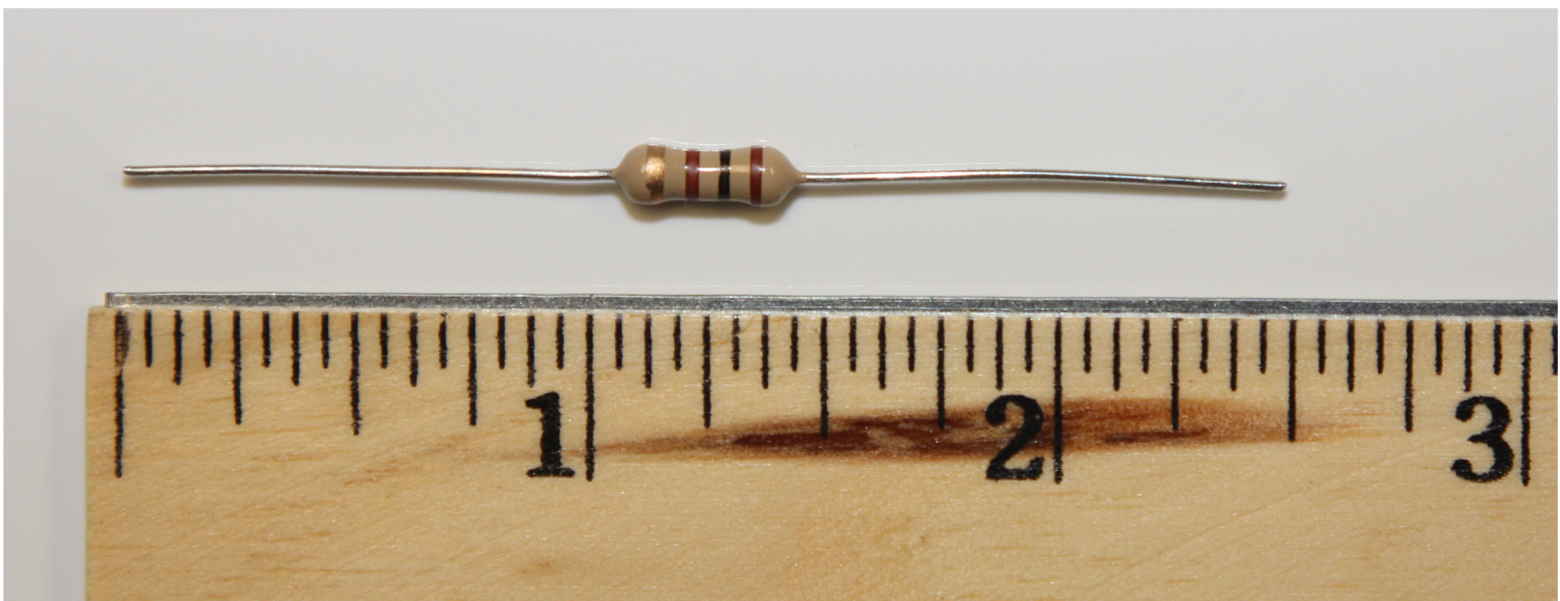
Ladies and Gentlemen, over the past several months a few of our G1000 aircraft have experienced a burnt resistor (see photo below) in the seat select annunciator circuit. This circuit controls the back lighting of the seat select annunciator switch which permits communication from the rear seat. The location of the annunciator switch varies from above the prop and mixture controls on our early model G1000s to the center console just below the prop and mixture controls on our later model G1000s. When the resistor fails a brief amount of smoke with an electrical odor may be emitted from one of these areas of the instrument panel. Typically the failure of the resistor is instantaneous and the smoke dissipates in a matter of seconds. There is no danger of fire at anytime during the failure. The "ANNUN" circuit breaker on the mission master panel will pop and the circuit will remain open until the resistor is replaced and the circuit breaker is reset.

If one of your aircraft experiences this issue contact NHQ/LGM and we will coordinate with Yingling Aviation to replace the resistor. Yingling will work with your local avionics shop and provide the necessary parts and diagrams to repair and/or update the circuitry.
